PRELIMINARY ACCIDENT INVESTIGATION REPORT

9N-ANC (ATR 72-212A, MSN: 754) Aircraft

OPERATED BY YETI AIRLINES PVT LTD

February 13, 2023 (2079/11/01 B.S.)

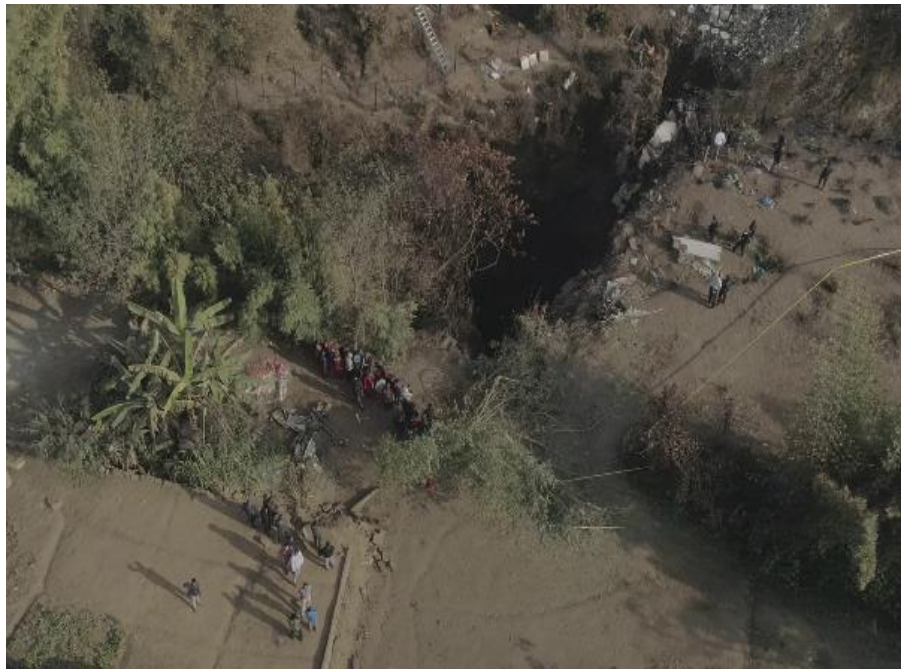
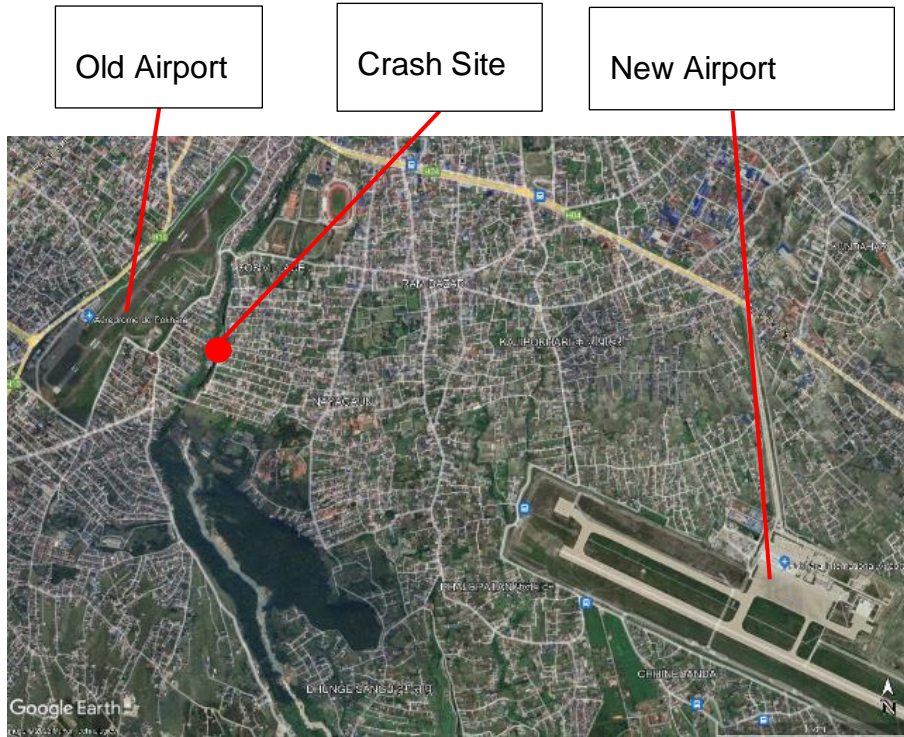
Geographical position of the accident site

1.9.1 The wreckage was located at a gorge on the bank of the Seti Gandaki River and around the bank.

- latitude: 28°11'51" N
- length: 83°59'6" E
